## **Limited Visual Dam Safety Inspection Summary Report**

**MA-058**

**Honokowai Reservoir**

**May 2006**

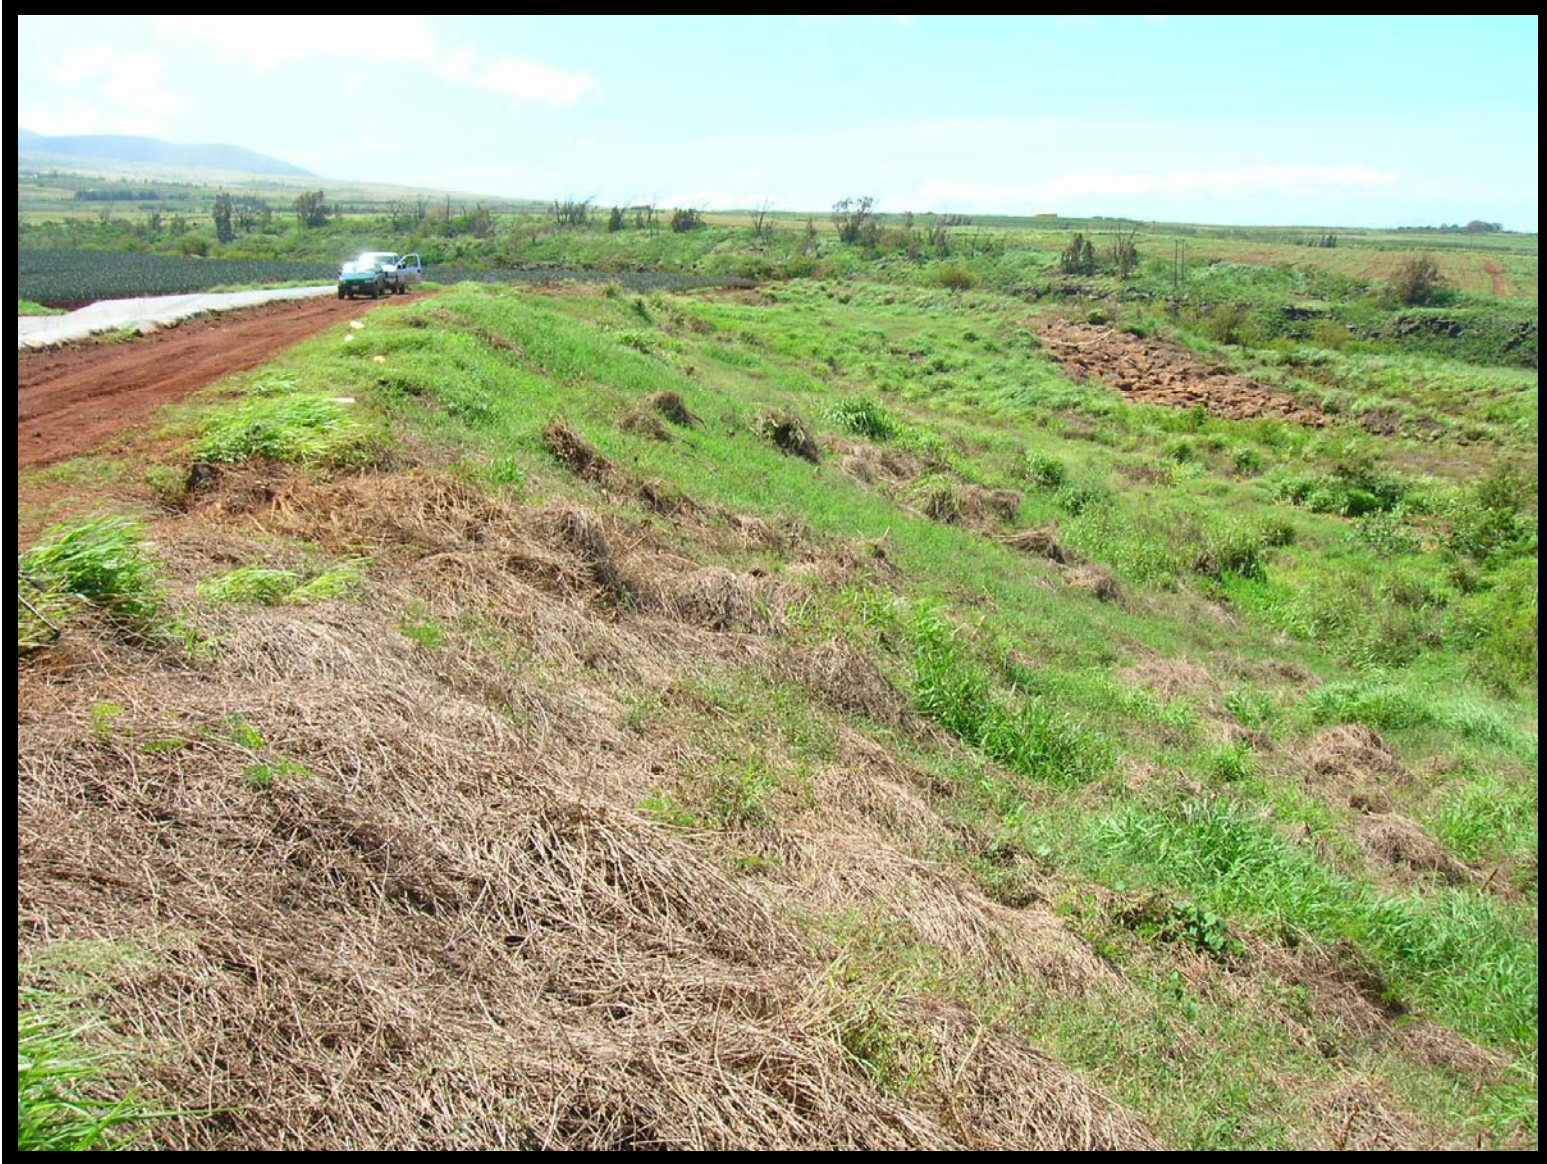
Erosion, cracks and sinkholes were not visible, because of the dense vegetation growing on the slope.

The slope was covered with 12" to 24" tall grass, which made inspection difficult.

- a. The downstream slope appeared to be in fair to poor condition and requires corrective action.
- b. The downstream slope was not visible due to high grass and bush vegetation. Clear high vegetation and maintain low to enable easy visual inspection.

**058** View of the downstream slope of the dam. Note the tall grass covering the slope. The grass should be kept short.

Recommendations: The downstream slope, abutments, and toe area was covered with tall grass (up to 24" tall) which made inspection of these features difficult. The grasses should be short (less than 6") to aid in visual inspection of the embankment, toe area, and abutments. Cut, dead brush covered portions of the downstream slope. The dead brush should be removed from the slope and disposed of offsite.

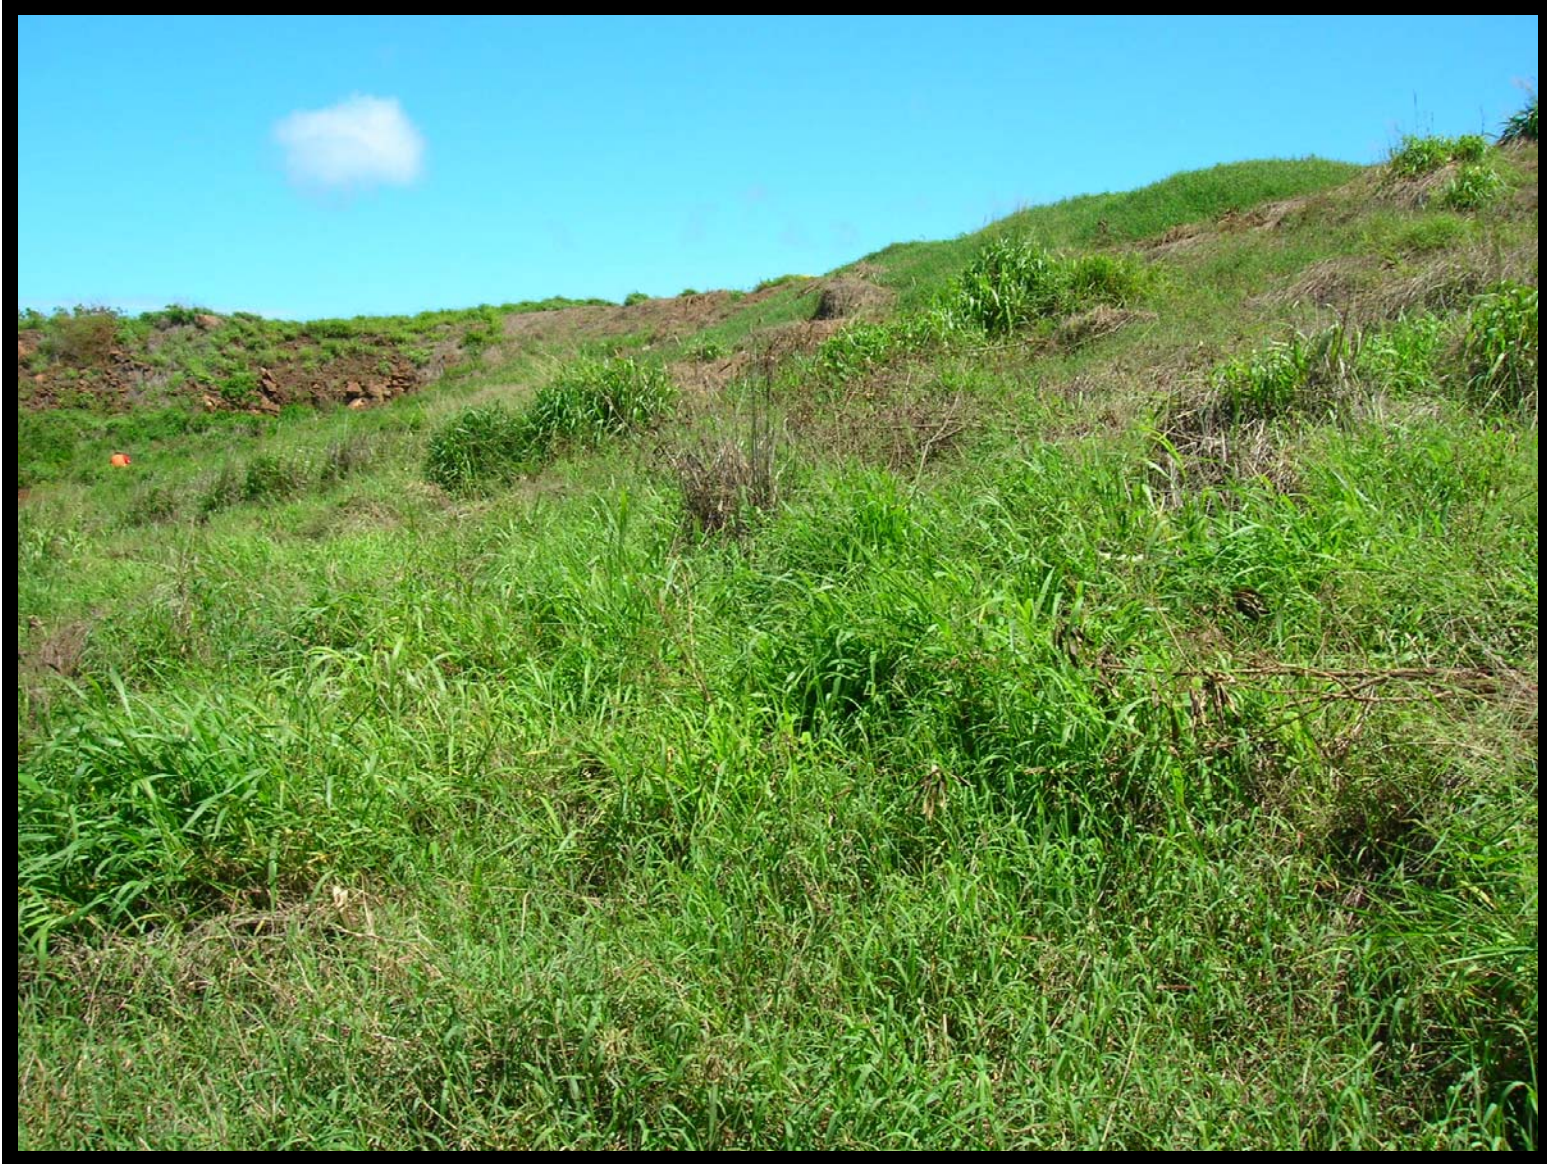
**058** View of the downstream slope of the dam. Note the tall grass covering the slope. The grass should be kept short.

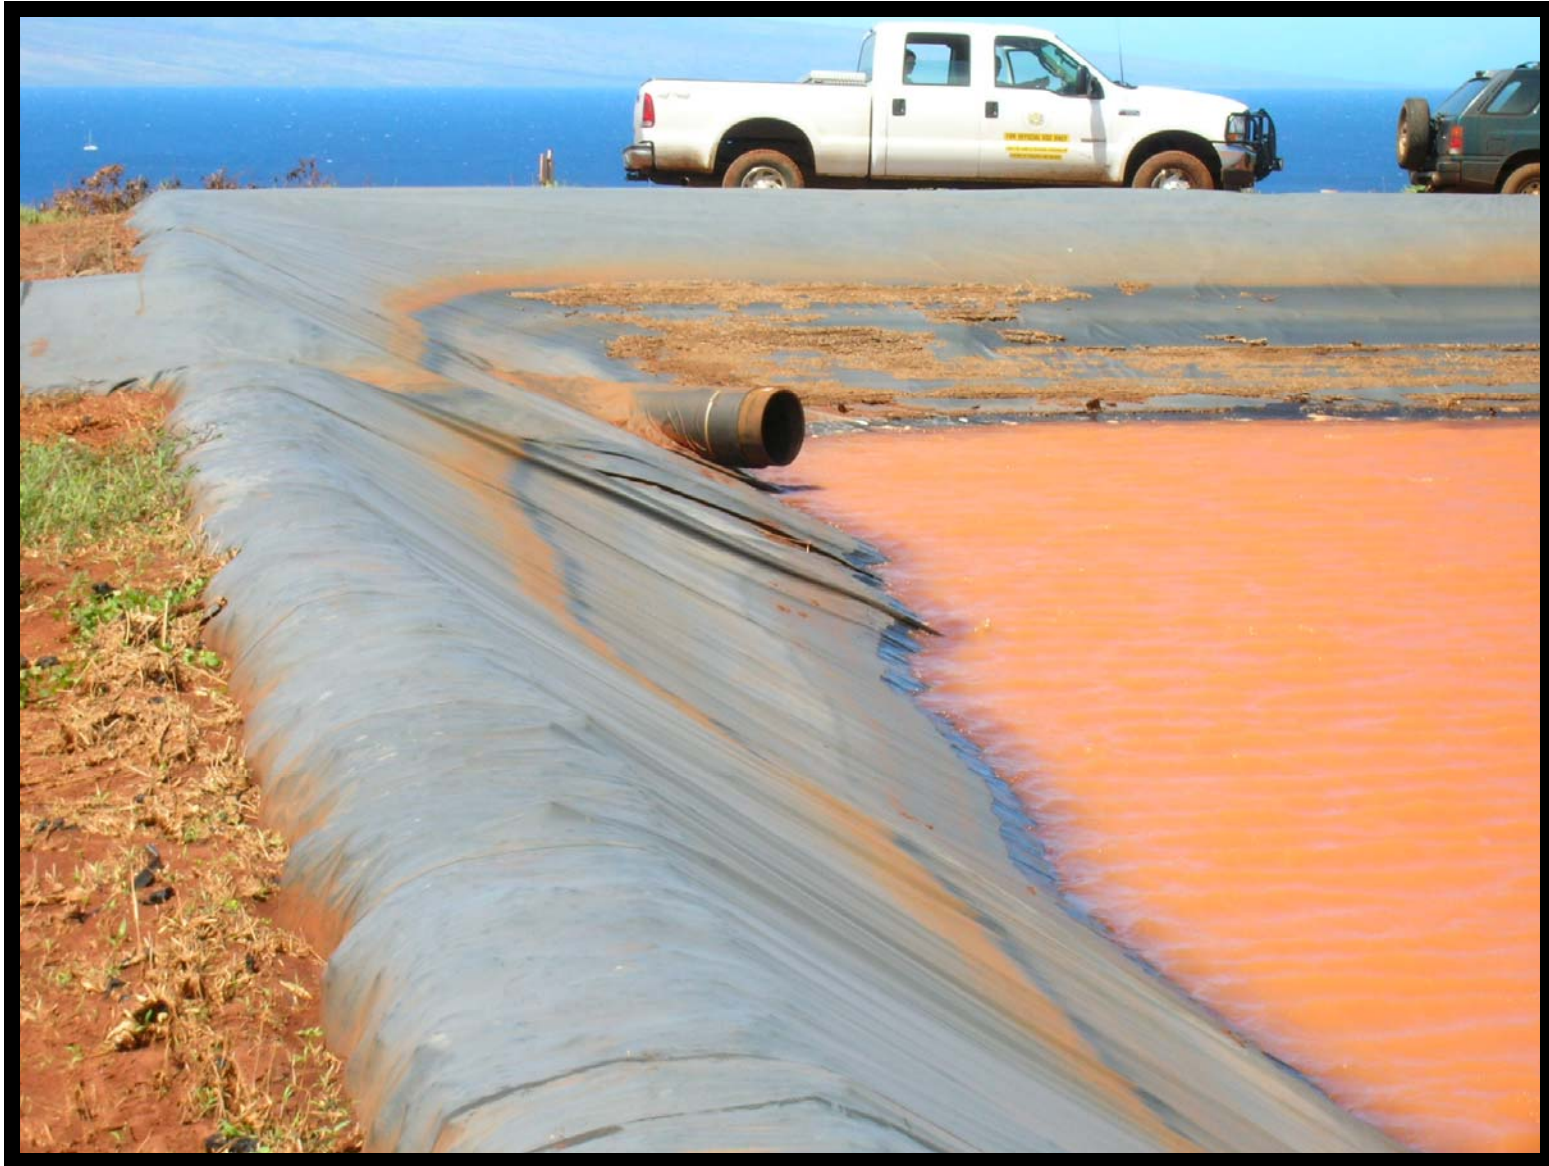
- a. The intake works were not tested.
- b. The intake works appeared to be in satisfactory condition, no corrective actions are required at this time

058 View of the 14" inlet pipe.

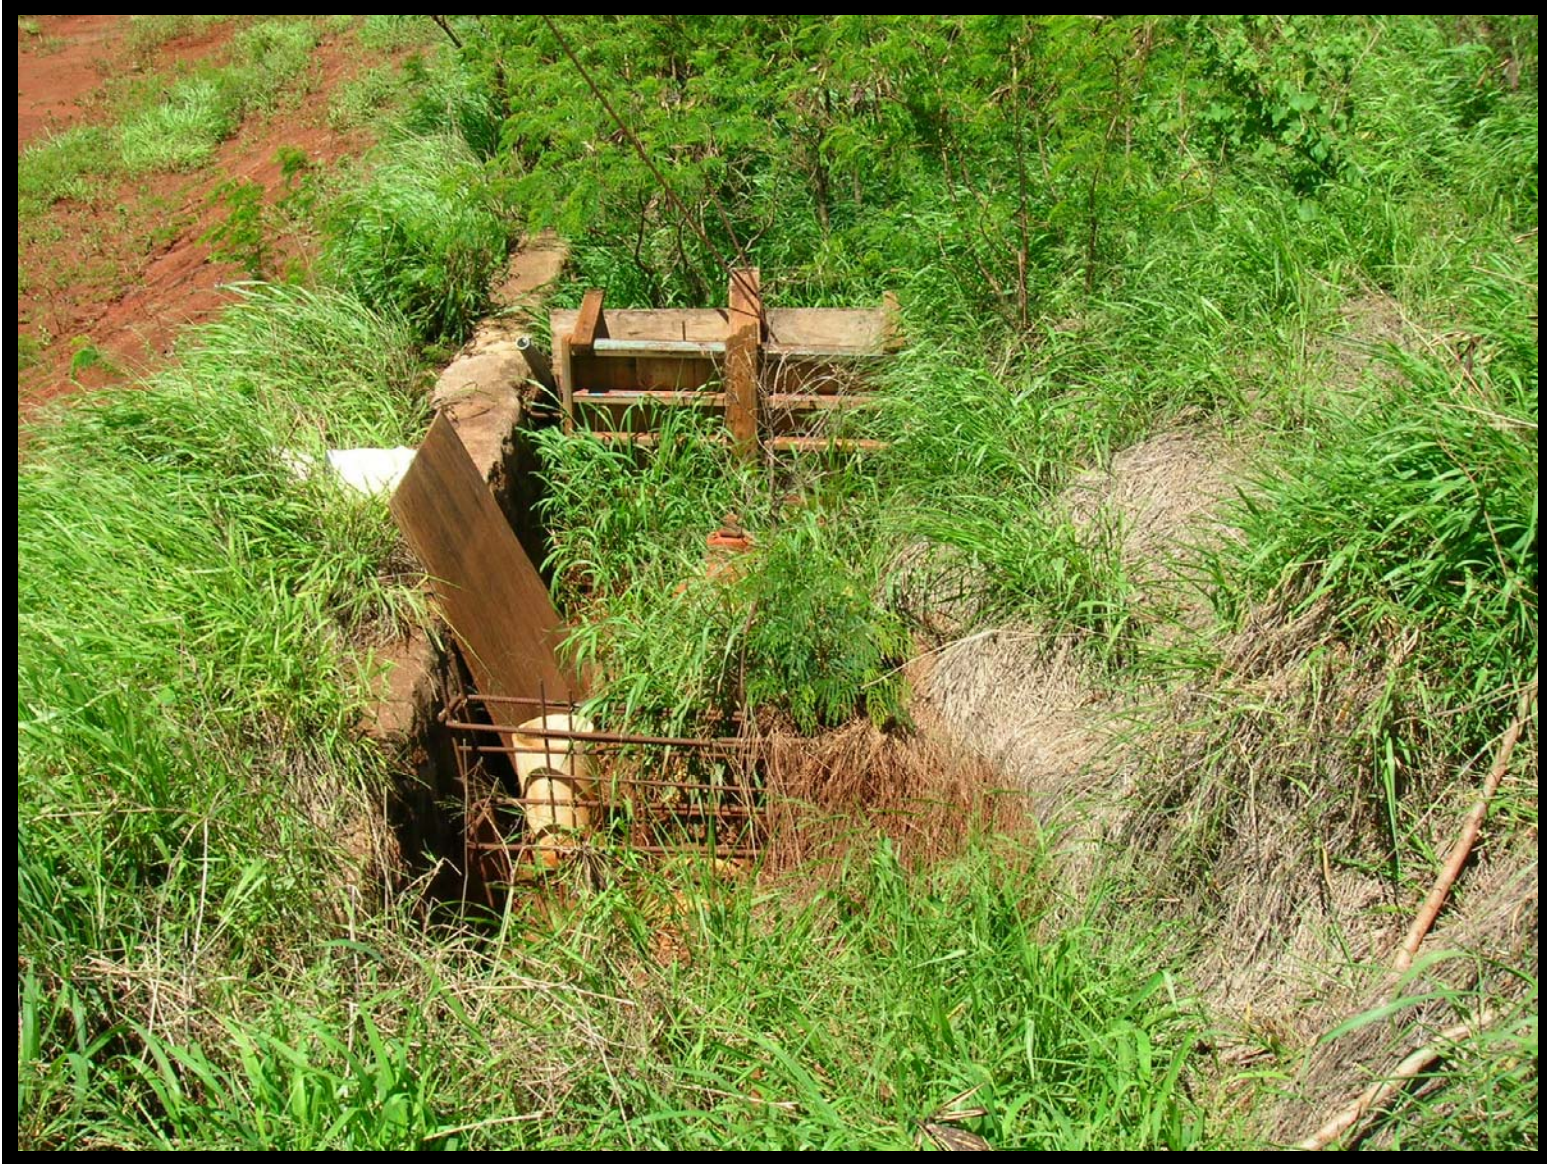
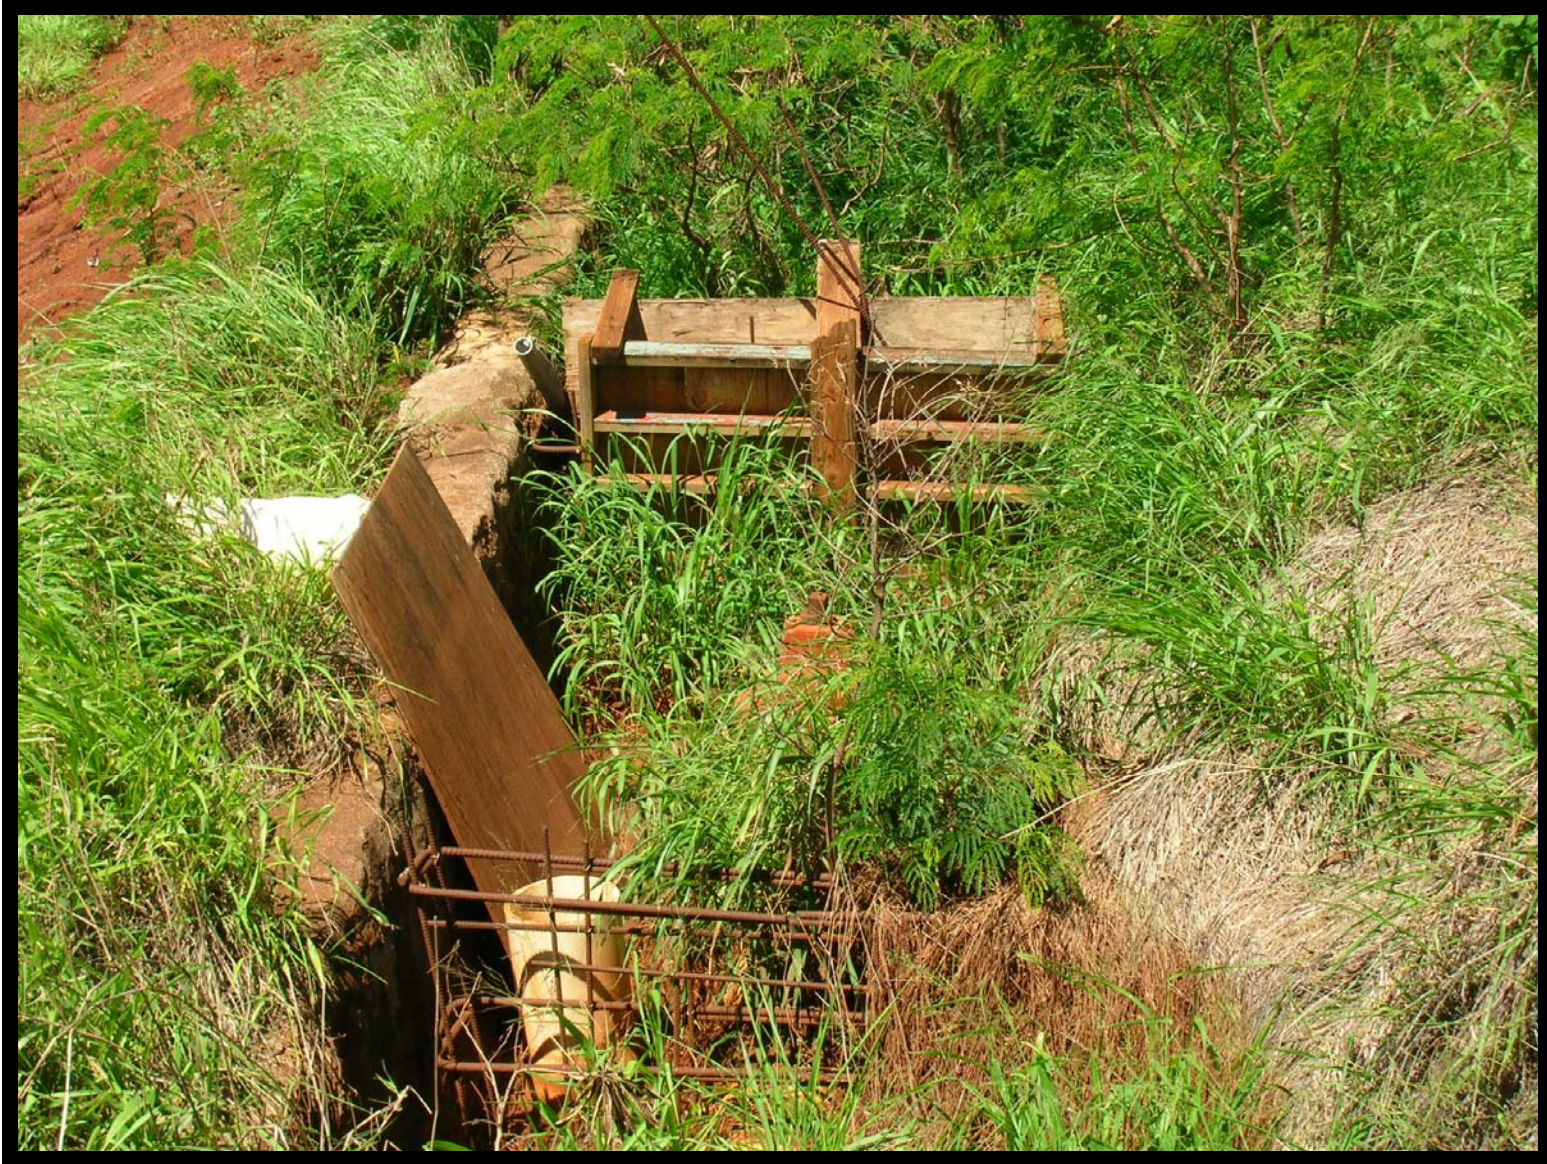
- a. The outlet works were not tested.
- b. The outlet works appeared to be in satisfactory condition, no corrective actions are required at this time.

058 View of the outlet works at the downstream toe of the dam.

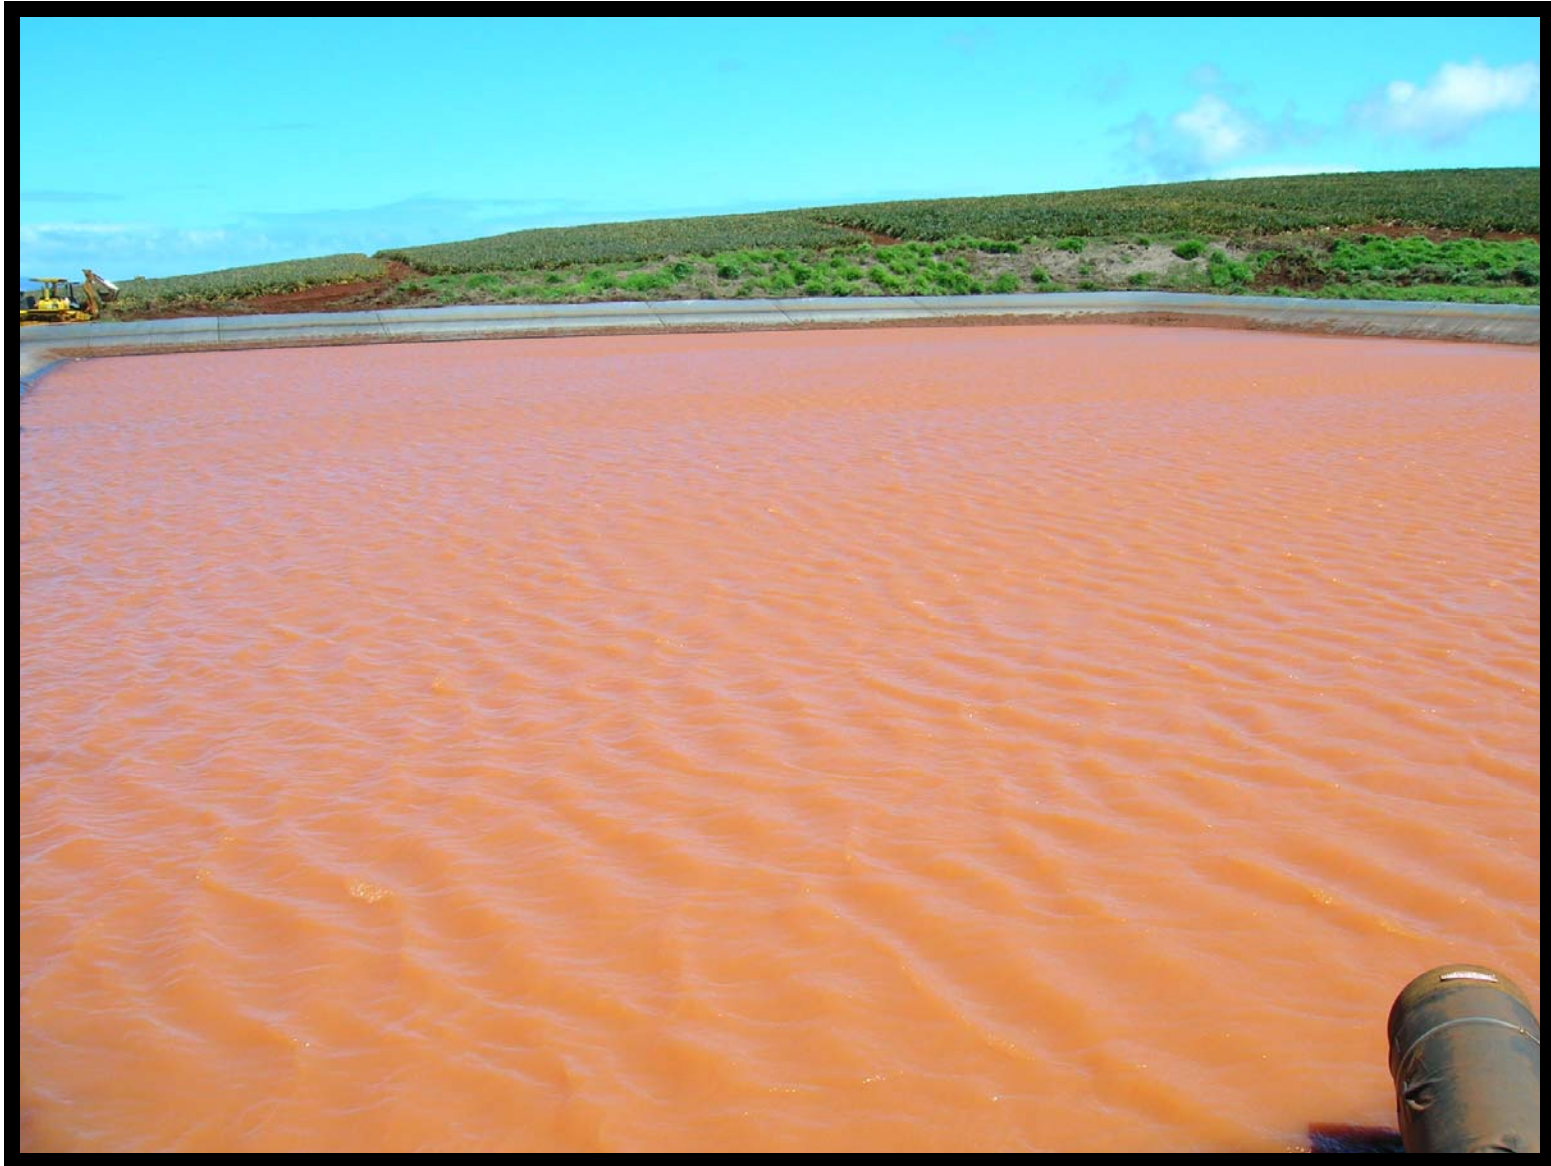
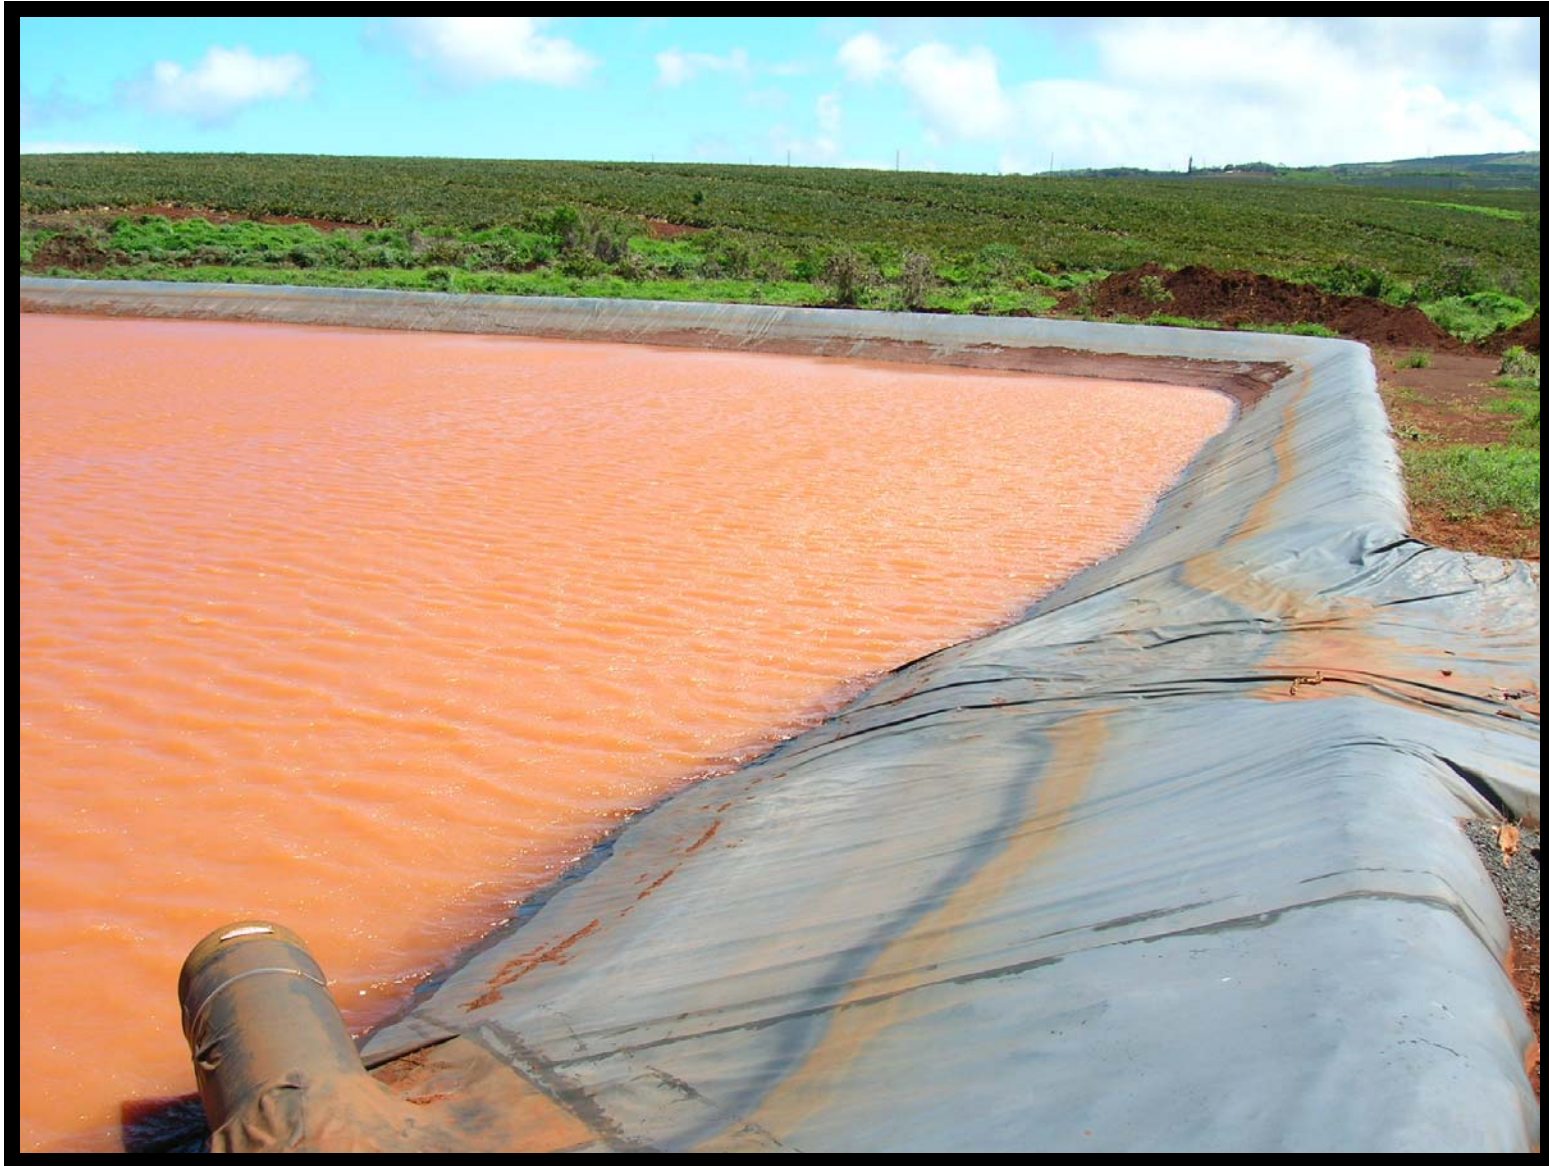
- a. The reservoir appeared to be in fair to poor condition and requires corrective action.
- b. A staff gage was not observed at the reservoir. Provide some method of quantifying the water level within the reservoir.

058 View of the reservoir (panorama)

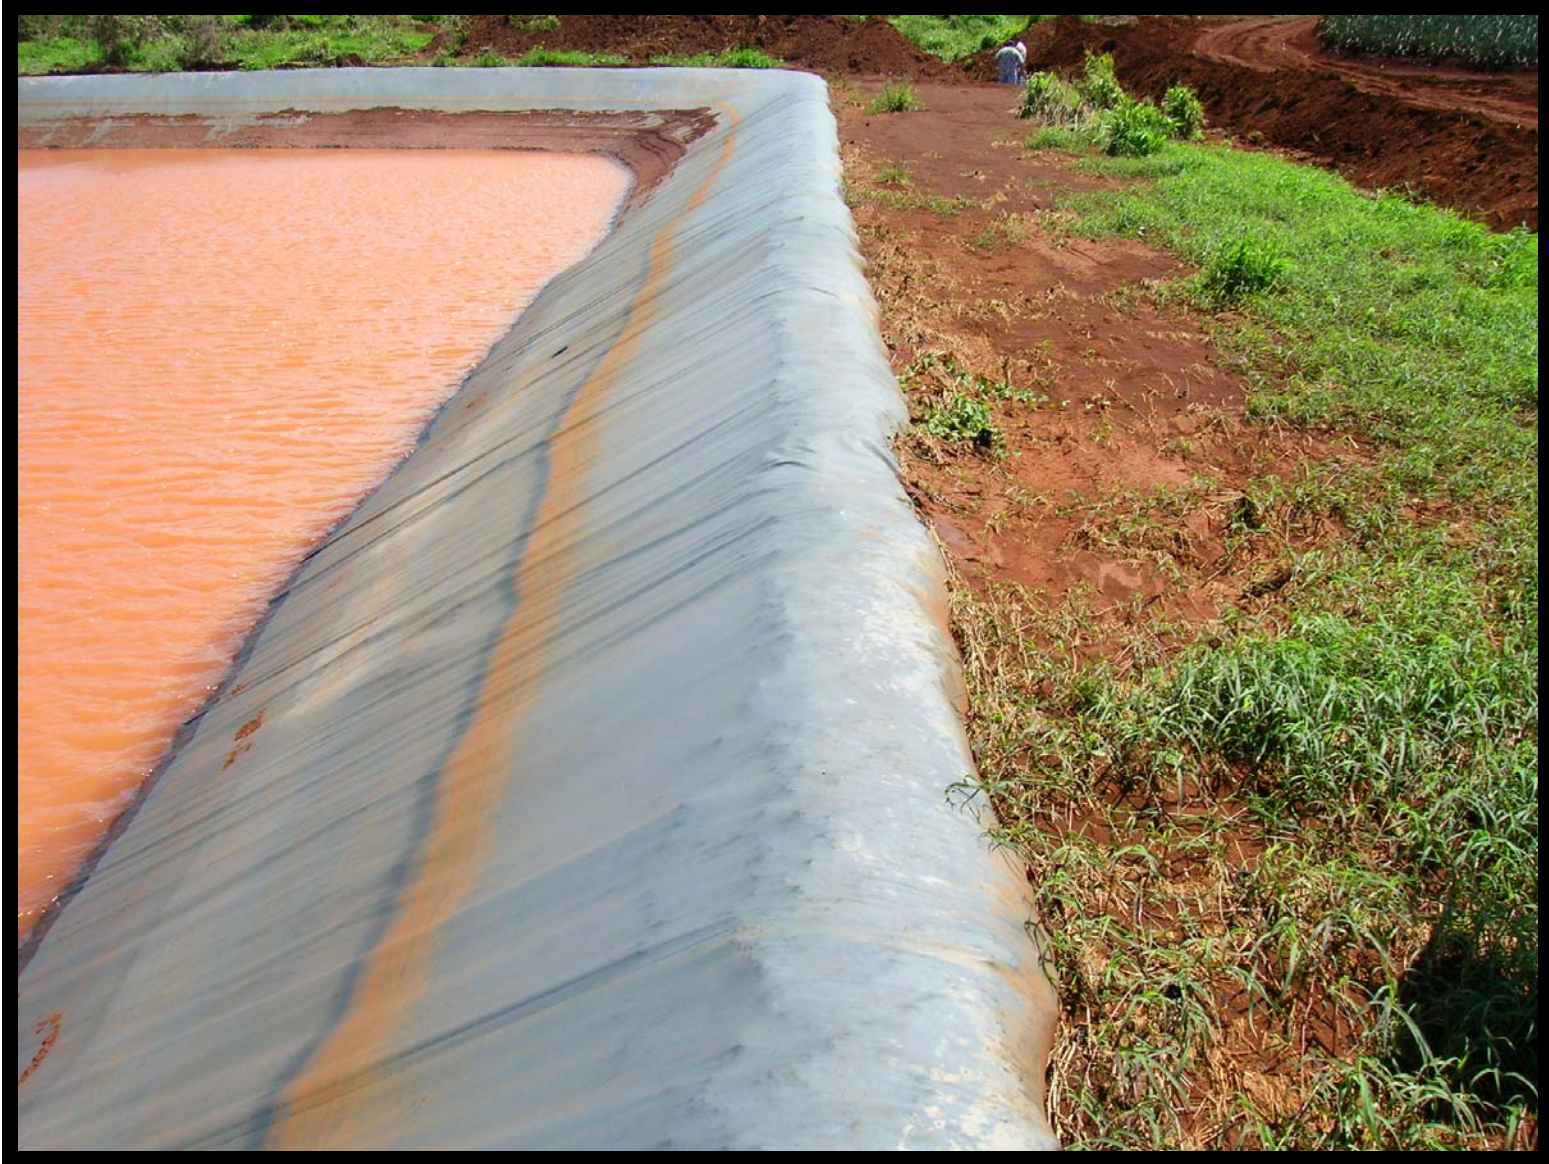
058 Rim of the reservoir just east of the spillway.

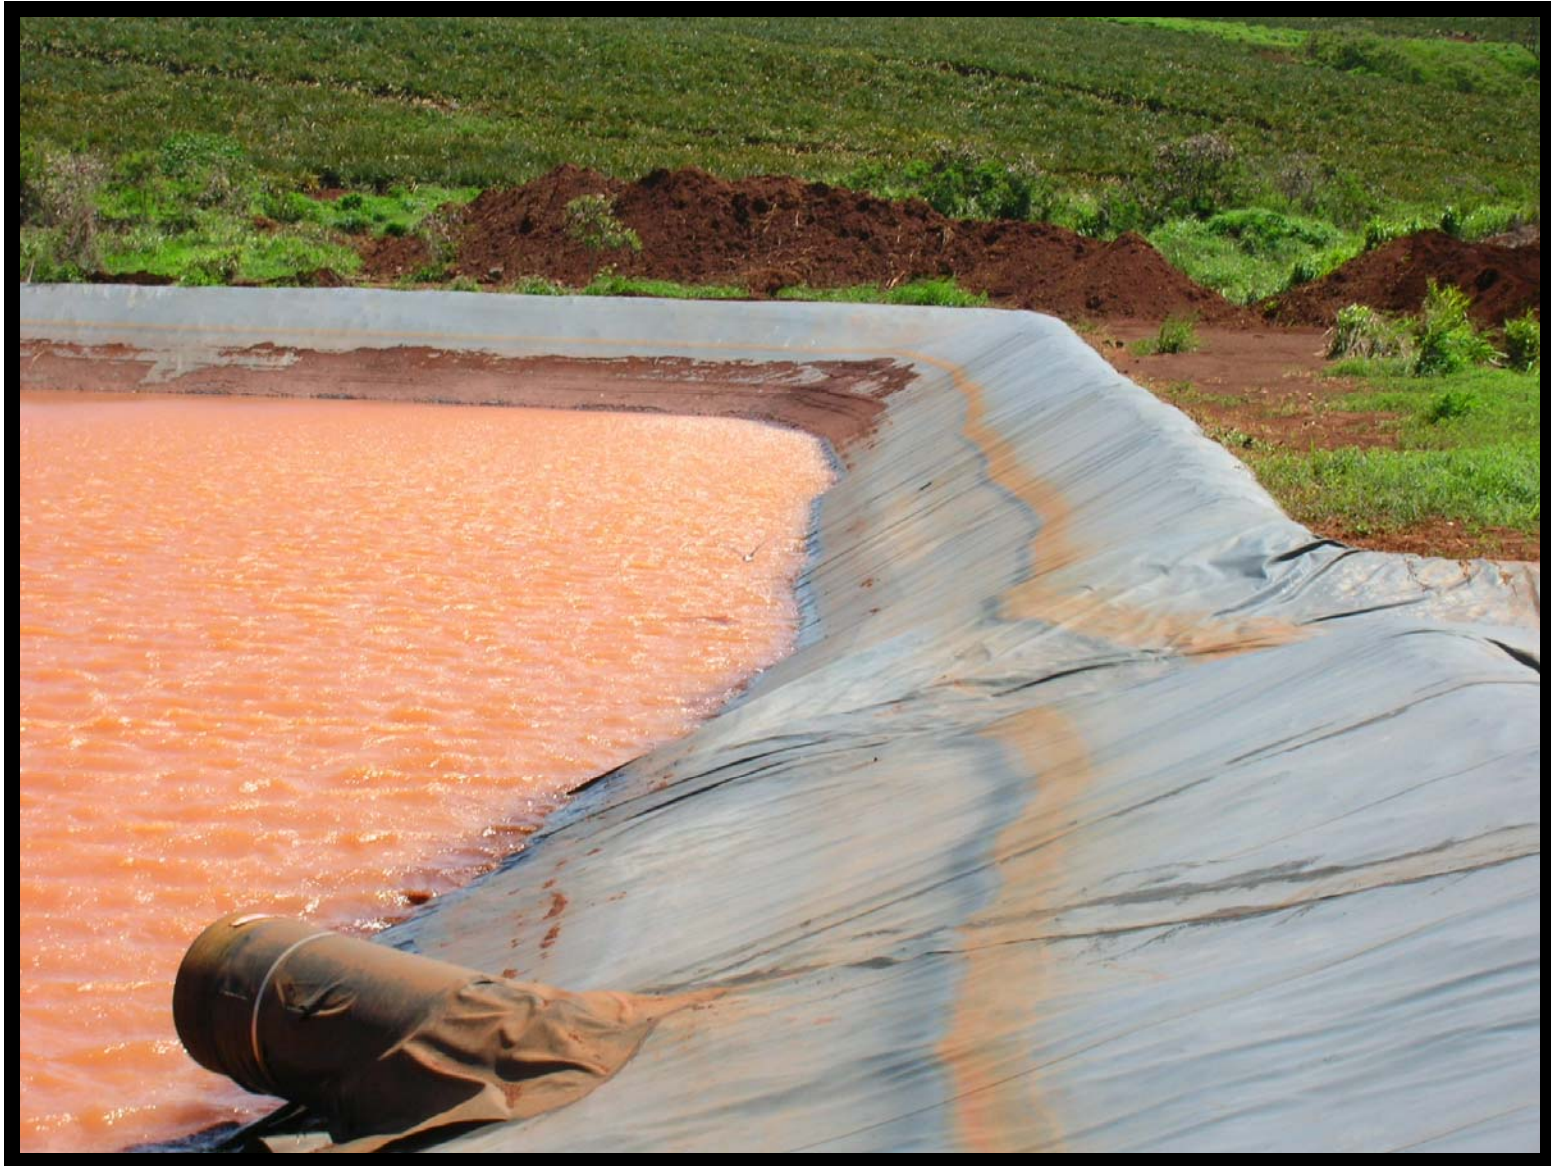
The slope protection is a HDPE liner. The liner is in good condition with no signs of cracking or deterioration.

058 View of the reservoir rim, spillway, and 14" diameter intake.
